PROBLEM SOLVED™ PAPER

SOLUTION: Martin® Air Cannons

INDUSTRY: Cement

LOCATION: CEMEX USA Balcones Plant
New Braunfels, Texas

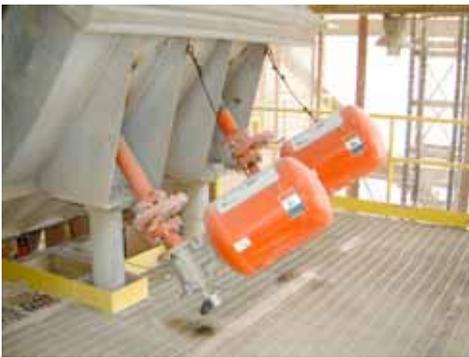
The Martin® Air Cannons installation included Martin® Thermo Safety Shields to protect maintenance workers from exposure to high temperatures.

Martin® Air Cannons were installed on the inlet to the fourth stage of the pre-heater. The installation included angled discharge nozzles, to prevent material falling back into the air cannons, and Martin® Thermo Safety Shield to protect maintenance personnel required to inspect or service the air cannon system.

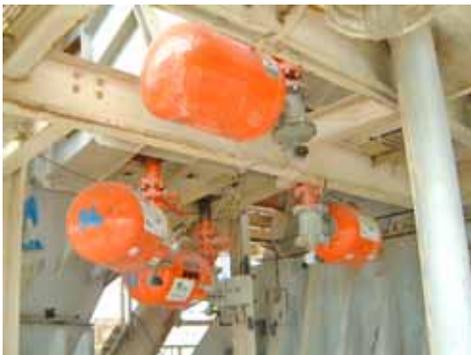
At the CEMEX Balcones Plant, the Martin® Air Cannon System paid for itself through improved production capacity in less than one week.

Periodic checks of airflow through the fourth stage inlets by plant personnel indicate there is no material buildup.

With the plant's increased production rate, the air cannon system paid for itself in less than one week.
